INDOOR AIR QUALITY ASSESSMENT

**Southbridge High School
25 Cole Ave
Southbridge, Massachusetts**

Prepared by:
Massachusetts Department of Public Health
Center for Environmental Health
Bureau of Environmental Health Assessment
Emergency Response/Indoor Air Quality Program
July 2004

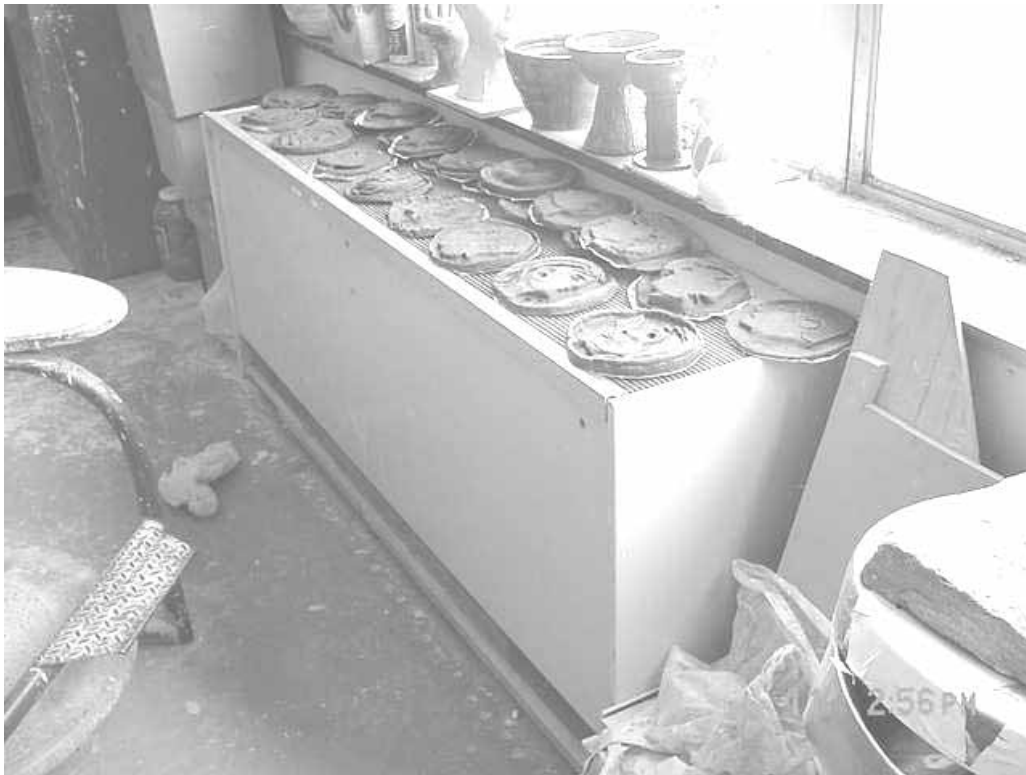
Picture 1

Fresh air in classrooms is supplied by a unit ventilator (univent) system ([Picture 1](#)). Univents draw air from outdoors through a fresh air intake located on the exterior walls of the building (Picture 2) and return air through an air intake located at the base of each unit (Figure 1). Fresh and return air are mixed, filtered, heated and provided to classrooms through an air diffuser located in the top of the unit. Univents had been deactivated in a number of classrooms surveyed (Table 1). Obstructions to airflow, such as books, papers and posters on top of univents, as well as bookcases, tables and desks in front of univent returns, were seen in a number of classrooms (Pictures 1 and 3). To function as designed, these units must be activated and allowed to operate during hours of school occupation. Importantly, univent air diffusers and return vents must remain free of obstructions.

Typical Univent, Note Art Objects Drying on Air Diffuser

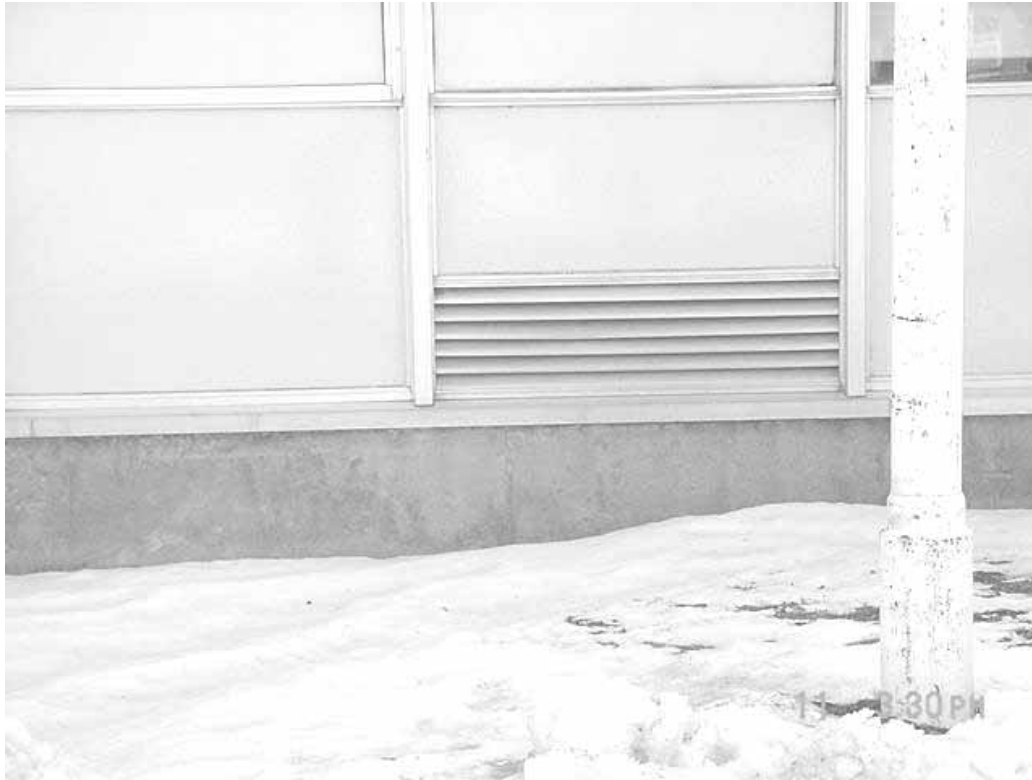
Picture 2

Univent Fresh Air Intake

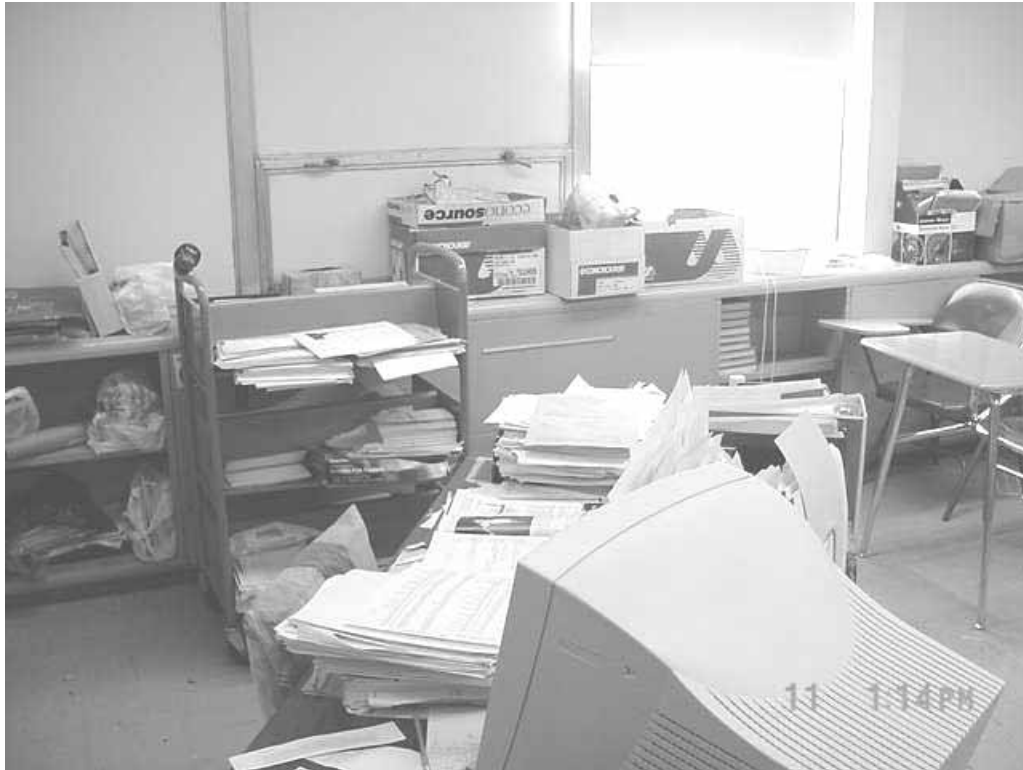
Picture 3

Classroom Univent Obstructed by Various Items

1. Operate both supply and exhaust ventilation continuously during periods of school occupancy, independent of classroom thermostat control, to maximize air exchange.
2. Remove all blockages from univents and exhaust vents to ensure adequate airflow.
3. Consult a ventilation engineer concerning re-balancing of the ventilation systems.

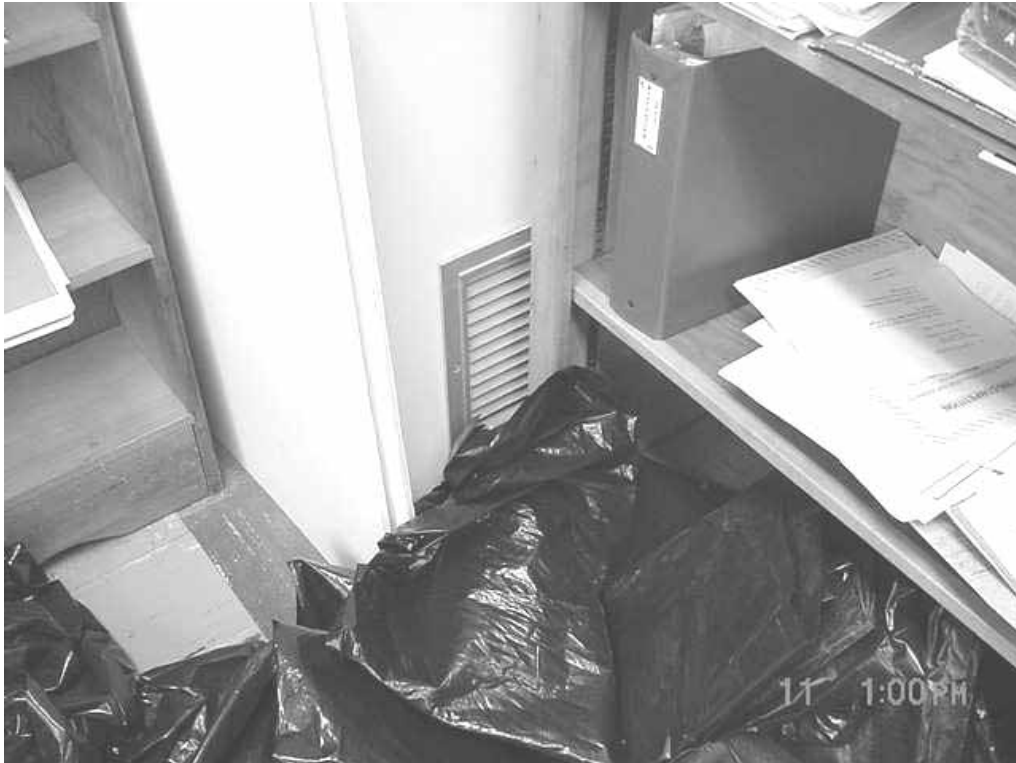
Picture 4

Mechanical exhaust ventilation for the original building consists of wall-mounted exhaust vents that are connected by ductwork to rooftop motors. Air was either drawing weakly or not at all in a number of classrooms, which can indicate that exhaust vents were deactivated or that rooftop motors were not functioning. As with the univents, exhaust vents in several classrooms were blocked with books, carts, desks and other obstructions (Picture 4). In order to function properly, these vents must be activated and remain free of obstructions. Also limiting exhaust ventilation is the location of vents in some classrooms. Picture 5 shows the location of a classroom exhaust vent near the hallway door. When a classroom door is open, exhaust vents will tend to draw air from both the hallway and the classroom. The open hallway door reduces the effectiveness of the exhaust vent to remove common environmental pollutants from classrooms. Without proper exhaust ventilation, environmental pollutants can build up in the indoor environment and lead to indoor air quality complaints.

Classroom Exhaust Vent Obstructed by Bookcase and Plastic Bags

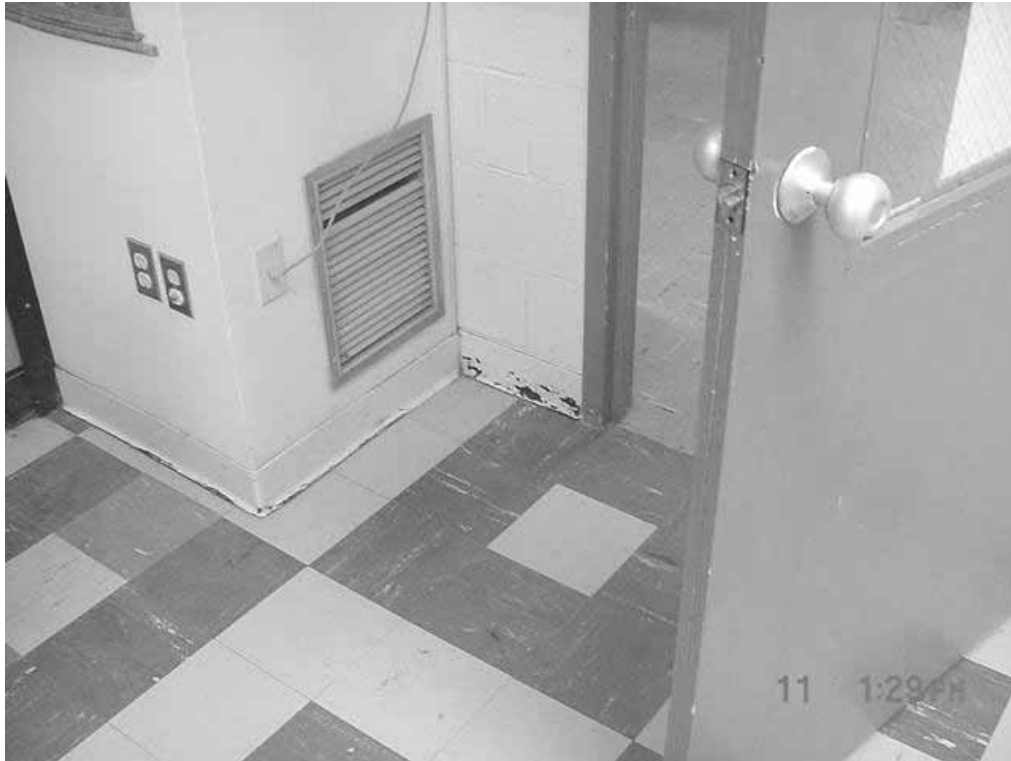
Picture 5

Location of Classroom Exhaust Vent and Hallway Door

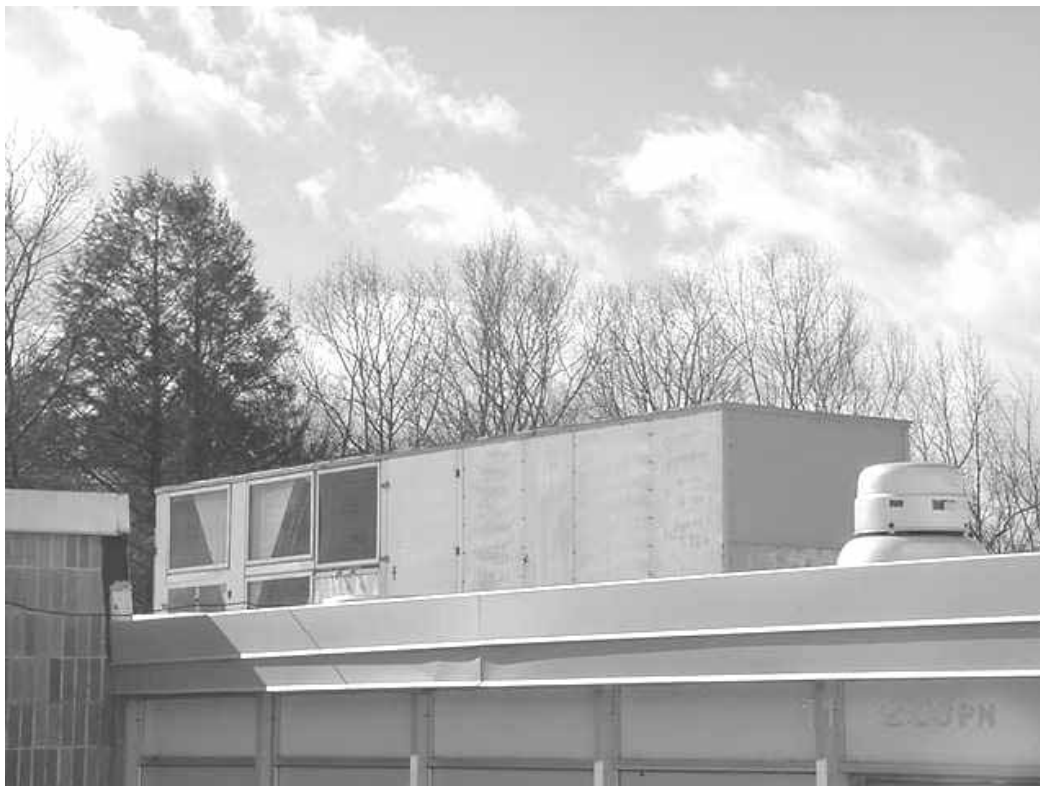
Picture 6

Mechanical ventilation in the 1976 addition is provided by a rooftop air handling unit (AHU) (Picture 6). Fresh air is distributed to classrooms via ceiling-mounted air diffusers. Airflow is controlled locally by a variable air volume (VAV) box. Each VAV box has a set of control dampers that open or close, depending on the temperature demand for a serviced area. The exhaust system in this part of the building is designed as an open ceiling plenum. School officials reported that the exhaust system was not functioning during the assessment.

Rooftop AHU on 1976 Addition

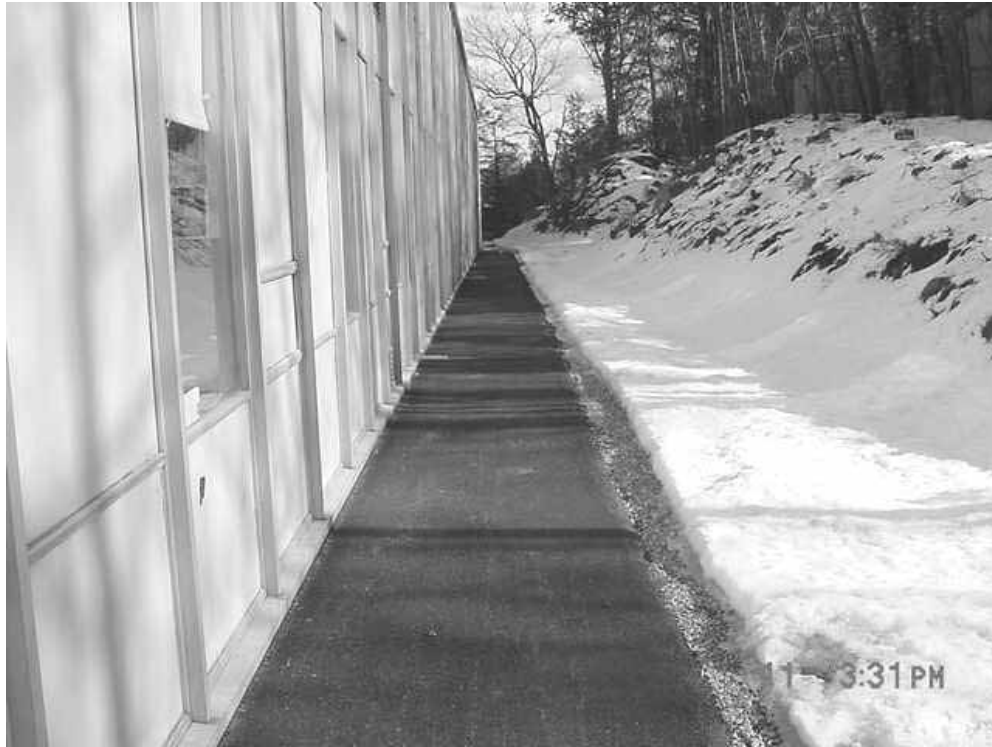
Picture 7

Paved Area behind Southbridge High School

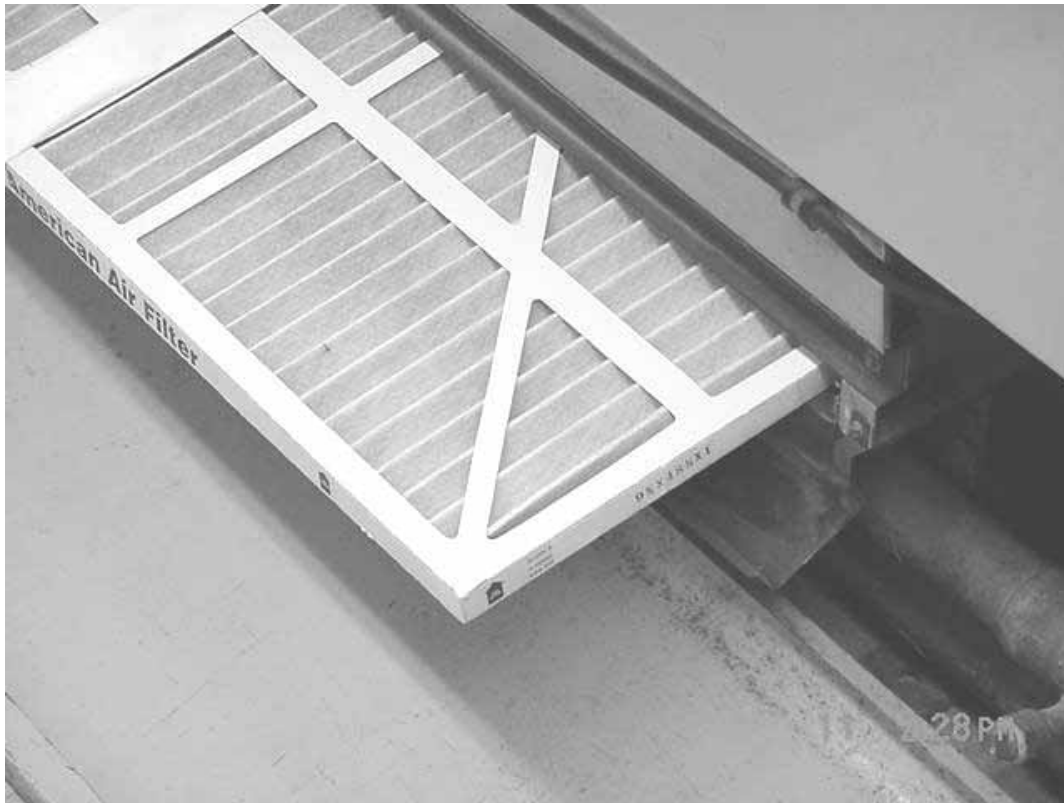
Picture 8

High Efficiency Pleated Filter in Univent

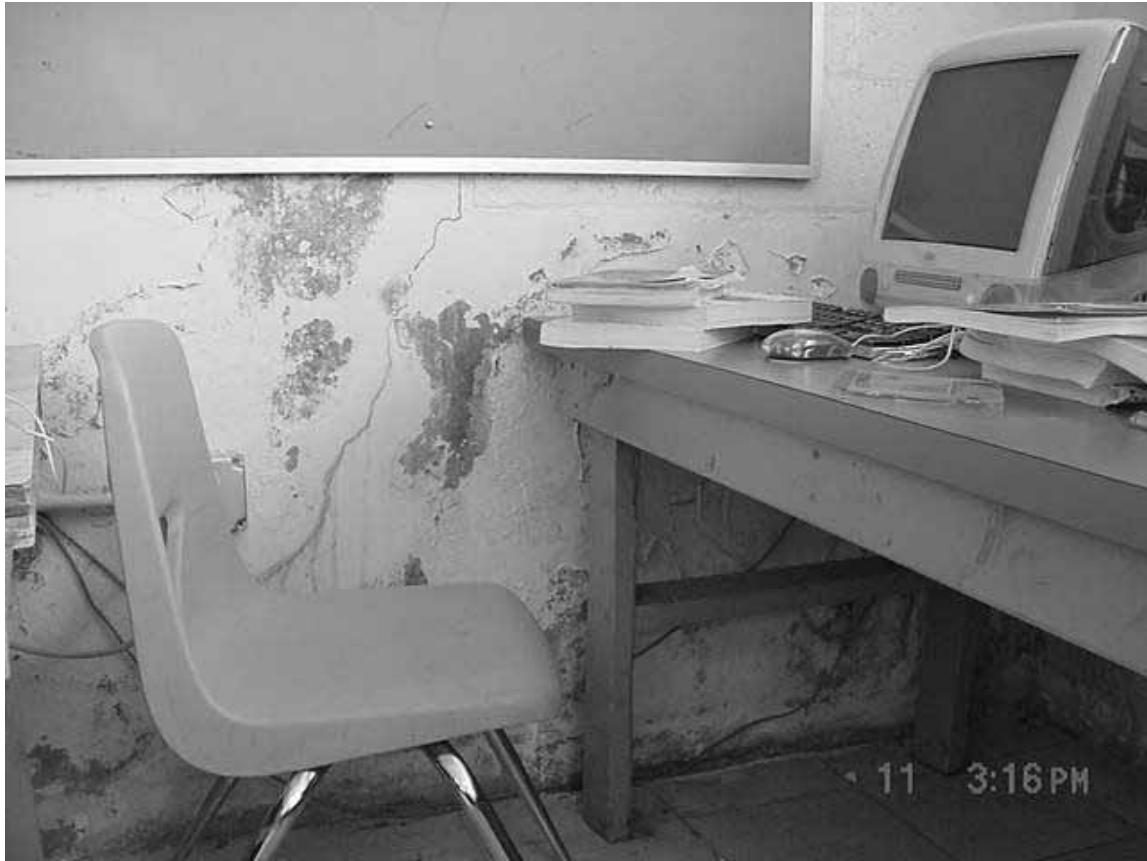
Picture 9

During the reassessment, BEHA staff noted the following conditions related to water penetration or damage within the SHS. Efflorescence (i.e., mineral deposits) and peeling paint was noted on walls in basement classroom C 008 (Picture 9). Efflorescence is a characteristic sign of water damage to building materials such as brick or plaster, but it is not mold growth. As moisture

penetrates and works its way through mortar around brick, water-soluble compounds in bricks and mortar dissolve, creating a solution. As the solution moves to the surface of the brick or mortar, water evaporates, leaving behind white, powdery mineral deposits.

Peeling Paint and Efflorescence in Basement Classroom 008

6. Examine the building envelope outside of basement classroom C 008 for signs of water penetration and make repairs.
7. Continue working with roofing contractor to eliminate roof leaks. Replace any water-damaged ceiling tiles, once leaks are repaired. Examine the area above and beneath these

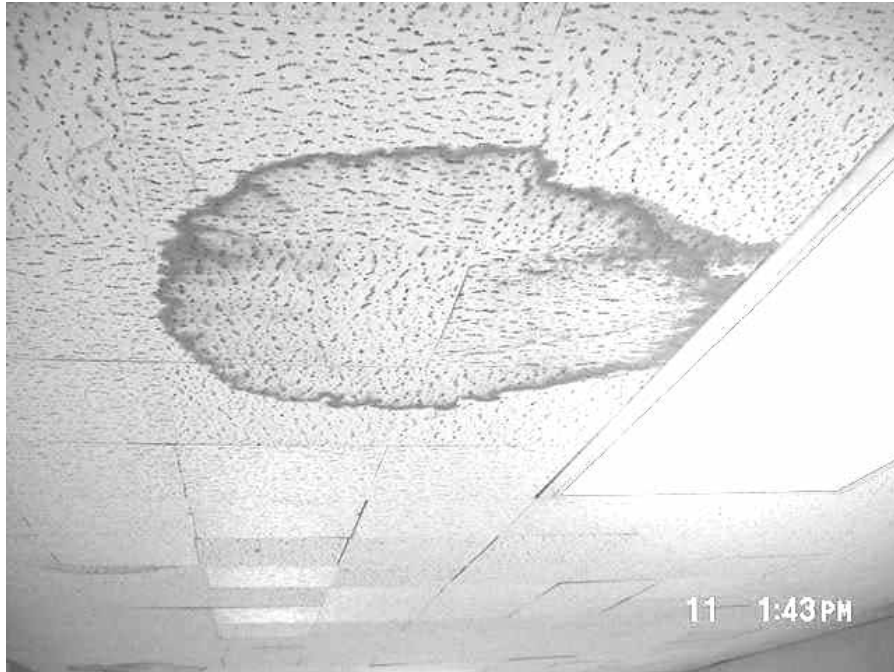
Picture 10

A number of areas had water-stained ceiling tiles, which can indicate leaks from the roof or plumbing system (Picture 10). School officials reported active roof leaks in the vicinity of classrooms C 224-C 220 and in the library. At the time of the MDPH reassessment, school officials were working with a roofing contractor to make repairs. Water-damaged porous building materials can provide a source for mold and should be replaced after a water leak is discovered and repaired. Increasing the difficulty of replacing ceiling tiles is the suspended ceiling design. The system consists of a suspended ceiling of interlocking tiles, which requires the removal of a number of tiles. This design renders replacement of water-damaged tile difficult.

Water Damaged Interlocking Ceiling Tiles

areas for microbial growth. Disinfect areas of water leaks with an appropriate antimicrobial.

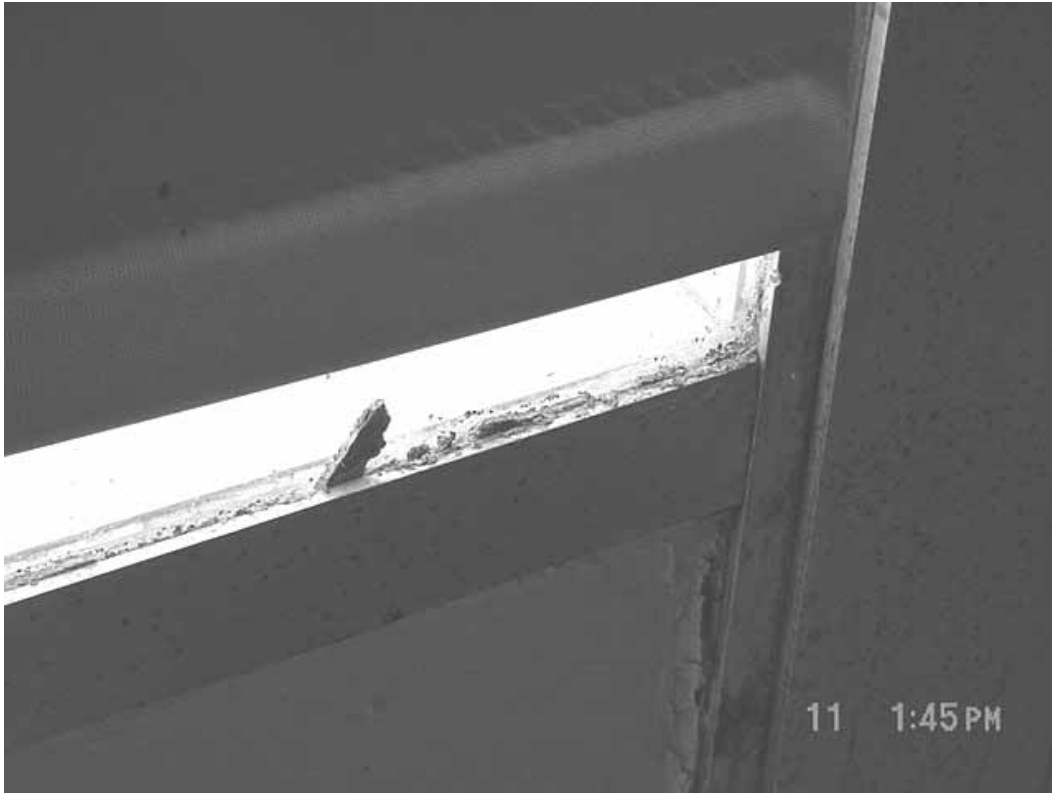
Picture 11

Exterior caulking around windows and frames was crumbling/damaged in a number of areas, indicating that the water seal is no longer intact (Pictures 11 and 12). The window in classroom 212 did not close properly and was taped shut (Picture 13). Replacement of caulking and repairs of window leaks are necessary to prevent drafts, water penetration and subsequent damage to building materials, which can lead to mold growth.

Crumbling/Damaged Window Caulking

8. Seal window frames and repair broken windows to prevent water penetration.
9. Repair/replace wood dust collection system in wood shop.
10. Determine if flammable cabinets are vented in a manner consistent with NFPA recommendations. If not, consider removing vent pipes and seal cabinet bung holes to render airtight.

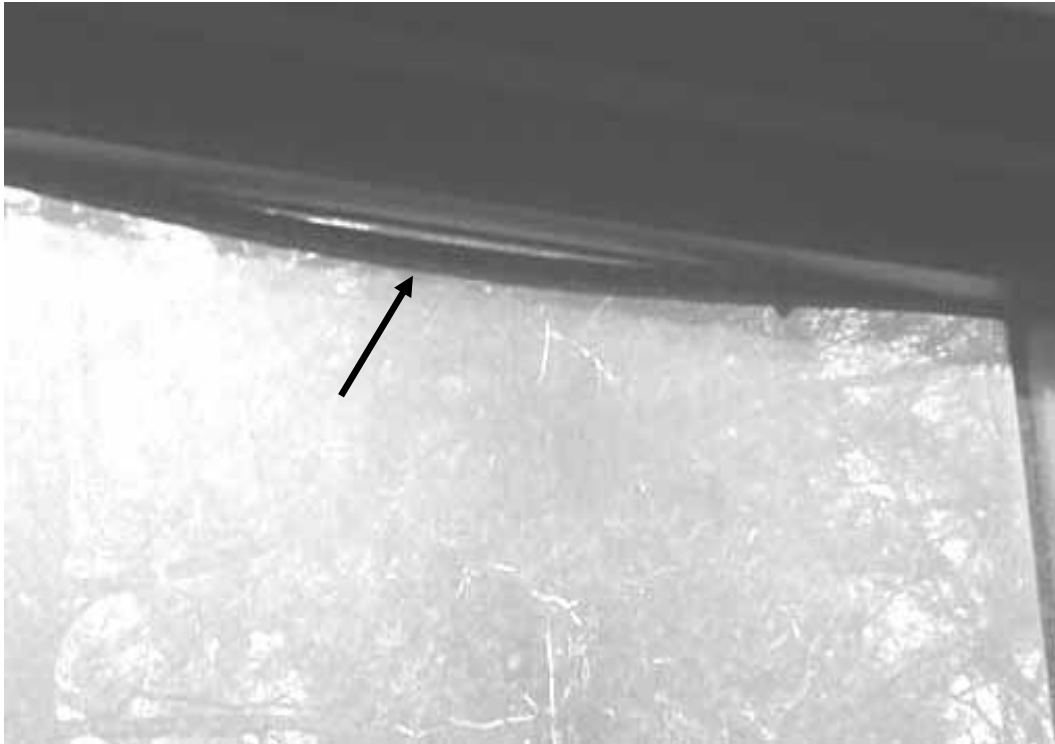
Picture 12

Loose/Failing Rubber Gasket around Window Pane

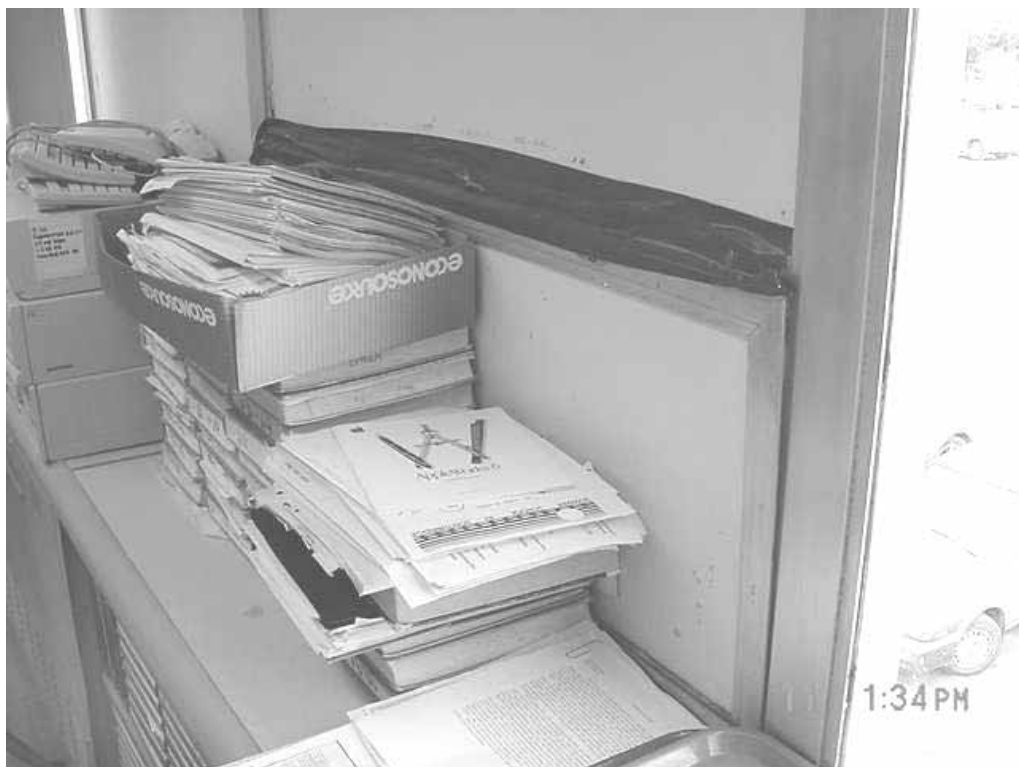
Picture 13

Window Duct-Taped Shut in Classroom 212

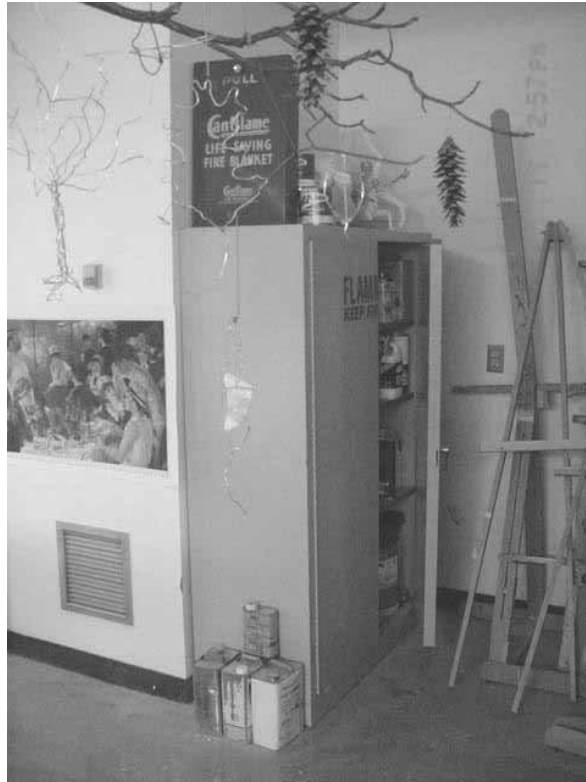
Picture 14

Several other conditions that can affect indoor air quality were noted during the assessment. The art room (C 115) contains a flammable storage locker; however, a number of flammable materials were noted on top of the cabinet or on the floor (Picture 14). The flammable cabinet in the chemical storeroom near science room 200 also contained a flammable storage locker. This flammable cabinet was vented to the outside (Picture 15). The National

Flammable Materials on Floor of Art Room Next to Flame Cabinet

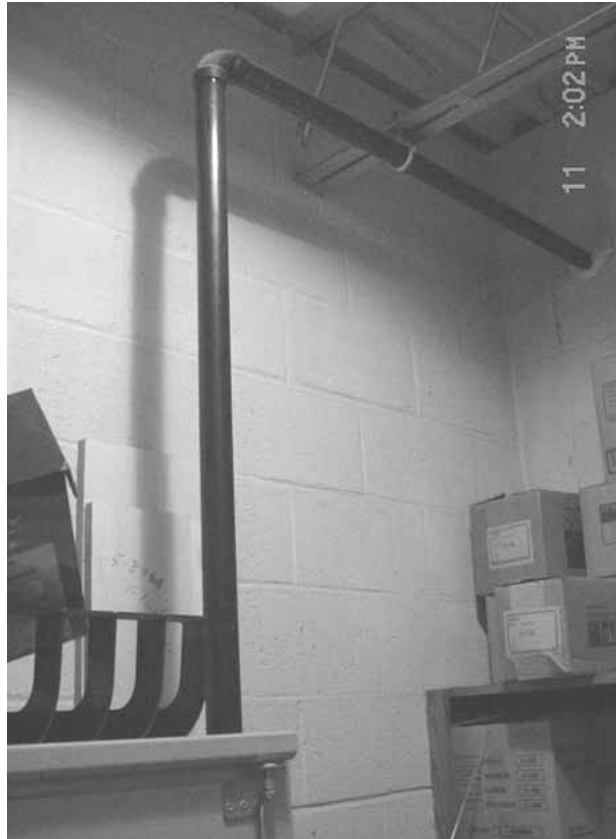
Picture 15

Flammable Cabinet Vented to Exterior Wall via Pipe

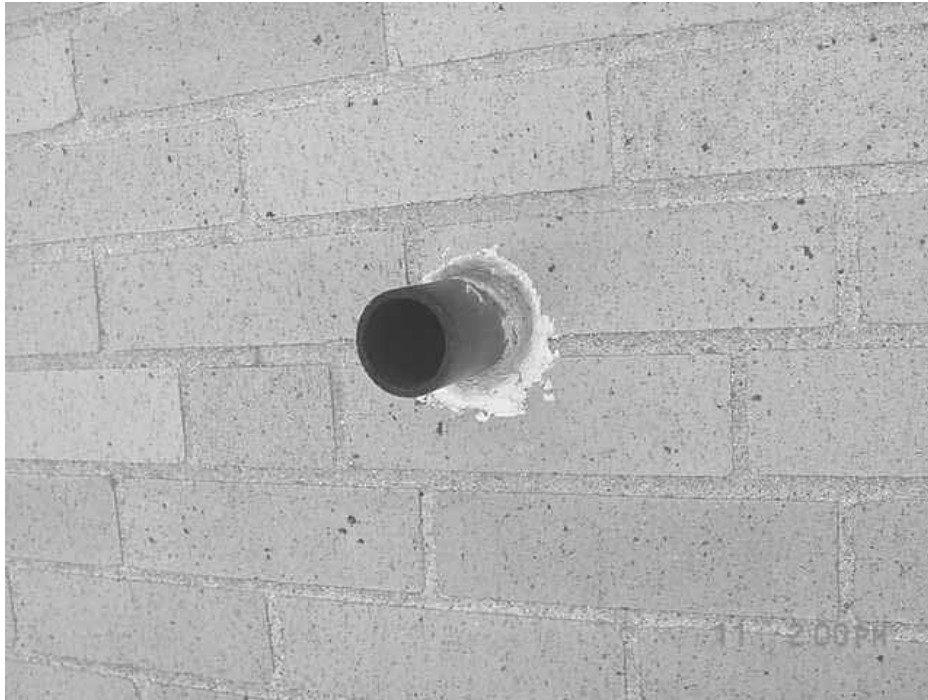
Picture 16

Fire Protection Association (NFPA) does not require venting in flammable storage cabinets. However, it is recommended that if a flammable storage cabinet is connected to a vent system, the vent system should not allow oxygen to penetrate the interior of the cabinet; the cabinet must also be vented directly outdoors and in a manner that does not compromise the specific performance of the cabinet (NFPA, 1996). It did not appear that this flammable cabinet had a mechanical exhaust fan in the ductwork or a damper to prevent backdrafting (Picture 16).

Exterior View of Vent Pipe, Note Absence of Motor or Baffle to Prevent Backflow
